Geoarchaeological Study of the Doush Temple: Analyzing Human-Environment Interactions, Kharga Oasis- Egypt

Islam Saber Amin^{1,*}, Heba Saber Amin¹

Doush Temple

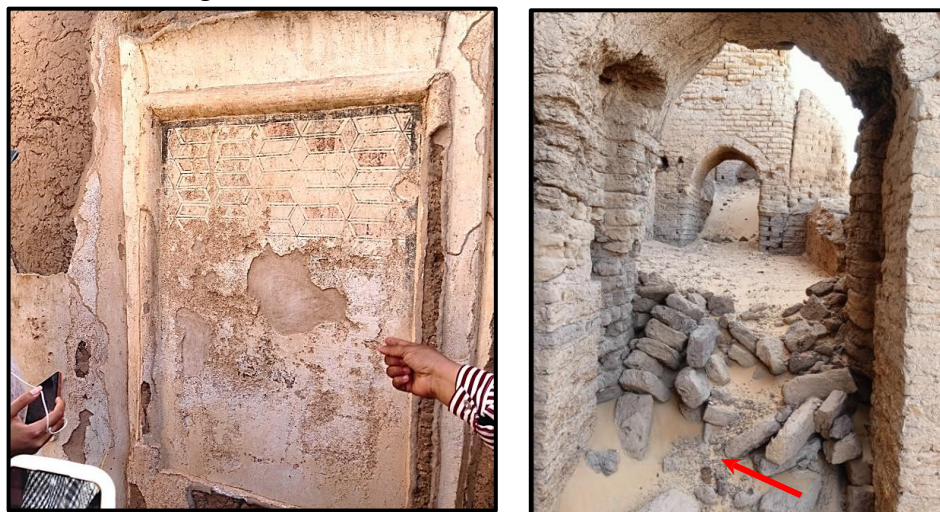
Figure 5. Erosive effects of windborne sand on the Doush Temple structure

While sand deposition can act as a form of preservation, it also poses serious risks to the temple, particularly in the exposed areas. Windborne sand acts as a natural abrasive, eroding exposed stone surfaces over time. When the wind carries sand at high velocities, it

transforms into an effective erosive agent, gradually wearing down the sandstone and mudbrick that form much of the temple’s structure. This abrasive process is particularly detrimental to the more fragile parts of the temple, including its gateways and intricate carvings, which show signs of surface pitting and erosion (Fig. 5).

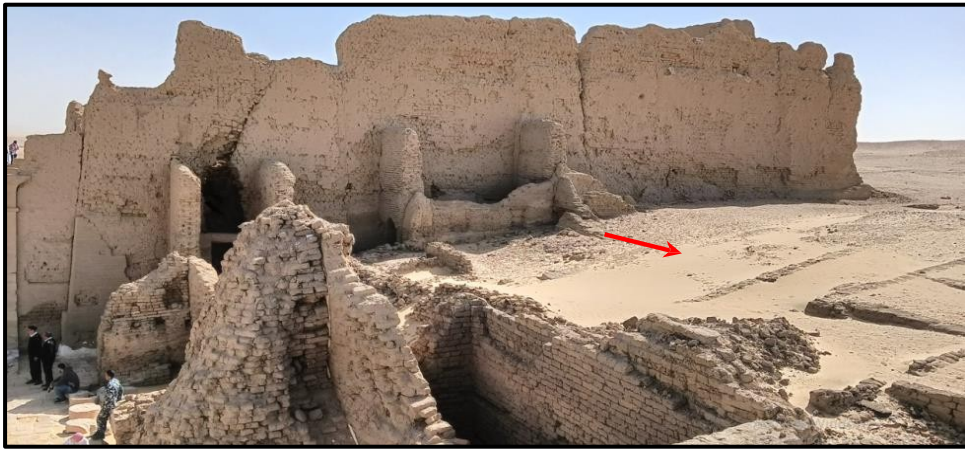
Figure 7. Parts of the Temple Buried Under Sand

Despite the destructive potential of sand, its role in the long-term preservation of the Doush Temple cannot be overlooked. Over centuries, portions of the temple have been buried under layers of sand (Fig.7), effectively shielding them from the harsh desert environment. Sand burial

acts as a natural protective blanket, insulating the covered sections of the temple from temperature fluctuations, wind erosion, and even occasional rainfall. This insulating effect has helped to preserve the structural integrity of parts of the temple that would otherwise have suffered from severe weathering.

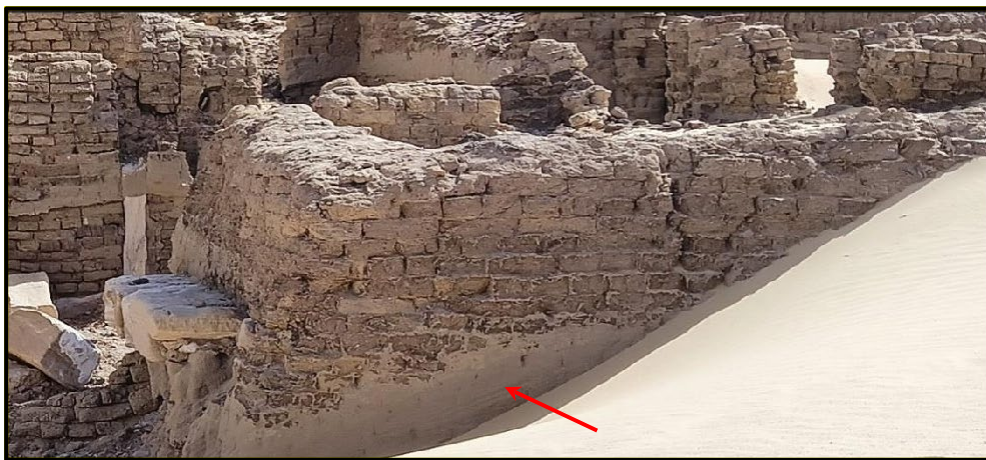
Similarly, at Doush, the parts of the temple that remained buried under sand for long periods show far less deterioration compared to exposed sections (Fig. 8). Sand burial can significantly slow down the weathering processes, particularly in arid environments where wind and temperature extremes are the primary agents of decay.

Figure 8. The Protective Effects of Sand Burial on the Doush Temple Structure.
 “Note that the buried sections still retain their outer plaster layer.”

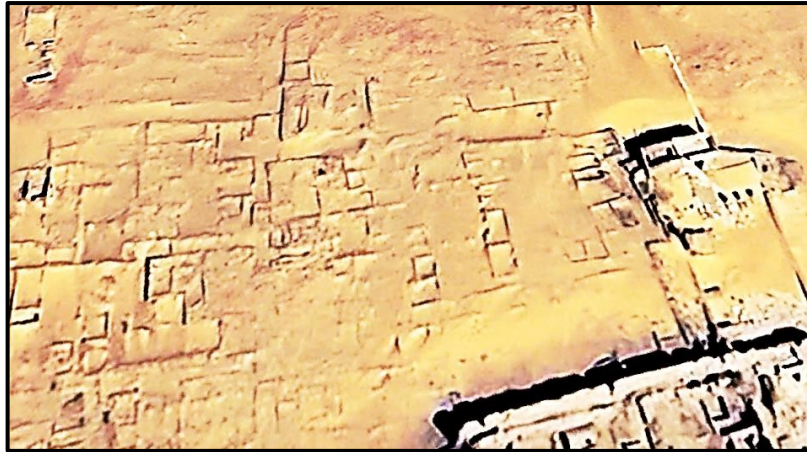
Figure 9. Satellite Imagery of Sand-Buried Portions of the Doush Temple

encroachment has clearly contributed to the degradation of some exposed sections, it has also played a critical role in protecting other areas by

shielding them from direct exposure to environmental stressors.

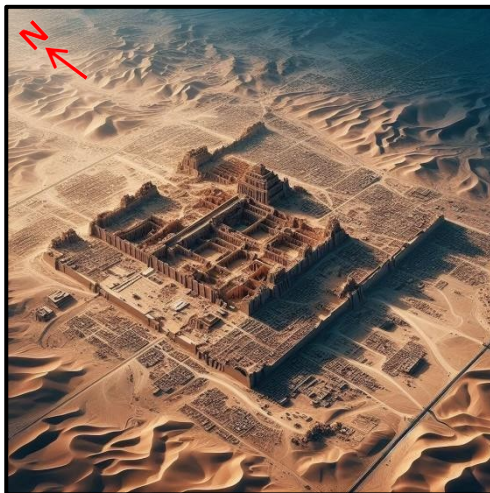
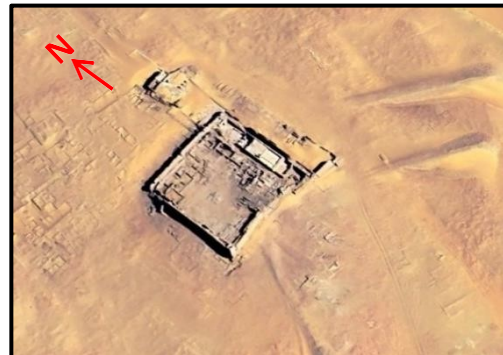
Figure 10. Reconstruction of the Doush Temple Using Machine Learning and AI Techniques

Advancements in machine learning and artificial intelligence techniques have been employed to help reconstruct the temple and its ancillary buildings, showcasing the vast size of the temple beyond what is apparent on the surface today (Fig. 10). The challenge for modern conservation efforts lies in managing this balance.

AI image

Real image

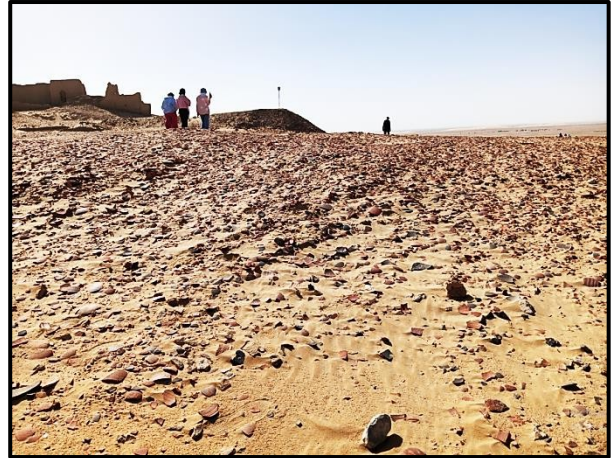
Figure 13. Distribution of pottery fragments at the Doush Site

During fieldwork at Doush, a remarkable observation was made regarding the distribution of pottery fragments. Scattered systematically across the site, the pottery shards suggest a deliberate effort to stabilize the sand dunes surrounding the ancient settlement. The evidence of this practice can be seen in several ways. Firstly, the distribution of pottery shards is regular, not indicative of waste disposal, but of purposeful placement (Fig. 13). Secondly, areas with fewer pottery fragments exhibit signs of wind-driven sand ripples, suggesting that in the absence of pottery, the sand is more prone to movement (Fig. 14). Lastly, pottery fragments

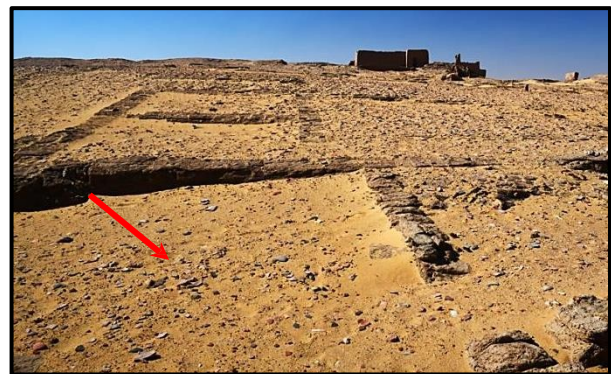
Figure 15. Pottery Fragments atop Structures Buried Beneath the Sand

were found atop structures buried beneath the sand, reinforcing the notion that these shards were actively used to stabilize the dunes rather than being remnants of past activity (Fig. 15).

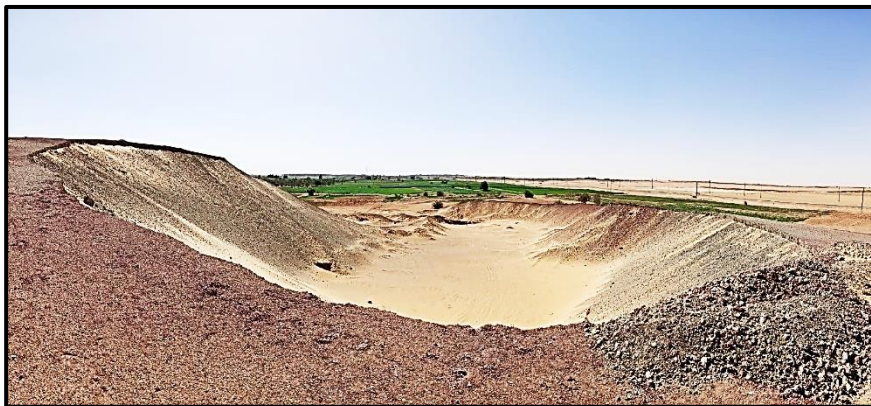
Figure 16. Dune stabilization techniques near Sana'a village

the technique observed near Sana'a village, where dunes are stabilized using rough materials like clay and coarse gravel (Fig. 16). The pottery at Doush was locally produced, further supporting the idea that ancient inhabitants used available resources to manage their environment

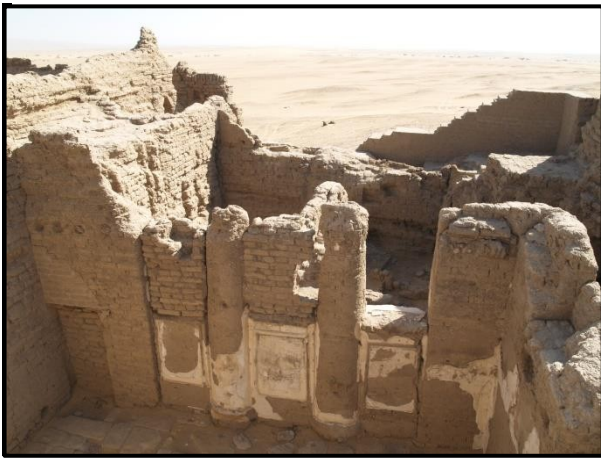
Figure 17. Erosion patterns affecting the upper sections of the Byzantine Church at Doush

been constructed during the Byzantine period, serving as a significant place of worship for local Christians. Its location within the ancient temple precinct underscores the continuity and adaptation of sacred spaces over time. The reuse of the earlier temple site for Christian worship not only reflects a transformation in religious practices but also highlights the resilience of the community as they integrated their faith into the existing cultural landscape. Furthermore, geoarchaeological findings indicate that the church has benefitted from environmental factors similar to those that have preserved parts of the Doush Temple. In some areas, the shifting sands have provided a protective layer for the church, although the upper sections are more vulnerable to erosion from wind and weathering (Fig. 17). This erosion presents a significant concern in the Kharga region, where extreme climatic conditions challenge the preservation of ancient structures. The interplay of these factors illustrates how both human and environmental elements have shaped the historical landscape of Doush.

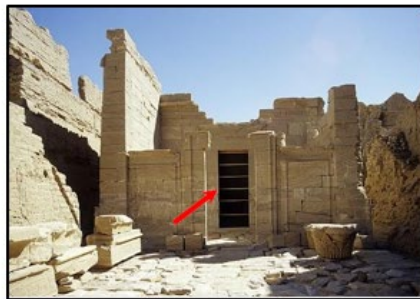
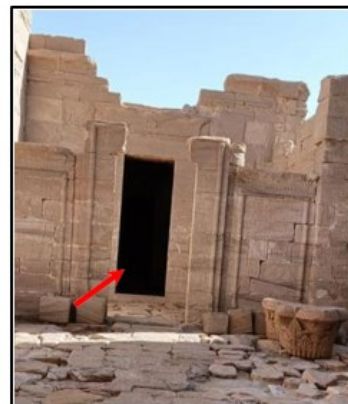
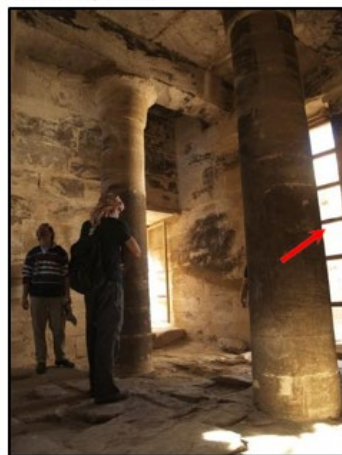
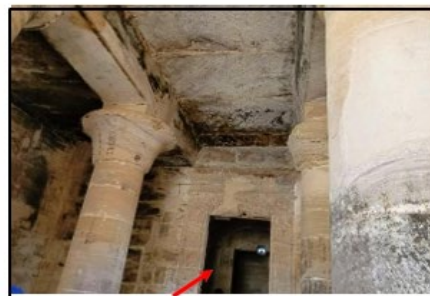
Figure 18. Wooden-Framed wire gates at the entrance to the hypostyle hall of the Doush Temple

significant preservation challenges over the years, with improper restoration methods and environmental degradation compromising its structural integrity. One of the more pressing issues was the installation of wooden- framed wire gates at key points within the temple, including the entrance to the hypostyle hall and the sanctuary. These gates, along with their wooden frames, have since been removed, leaving the interior of the temple exposed to environmental elements (Fig. 18). Without these barriers, the temple's chambers are now vulnerable to windblown sand, dust, and small animals, all of which can accelerate the wear and tear on the ancient stonework. This removal represents both a conservation failure and a missed opportunity to study the potential impacts that previous structural modifications had on the preservation of the monument.

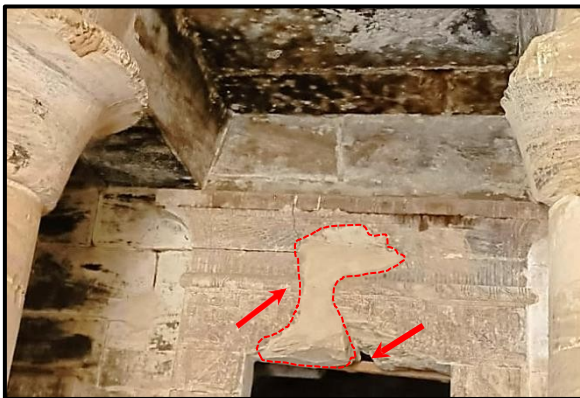
Figure 19. Improper Restoration Techniques Applied to Weathered Sandstone of the Doush Temple

In addition to the challenges posed by the gate removal, rudimentary restoration techniques have also been applied to damaged sections of the temple's sandstone. Above one of the now-removed gates, sandstone that had suffered significant weathering was "repaired" using a mixture of gypsum and sand (Fig. 19). This method is problematic for several reasons. Gypsum, while easily accessible and commonly used in quick repairs, lacks the long-term durability required for sandstone preservation. Over time, it becomes brittle, deteriorating more quickly than the original stone, and the mismatch in material properties between the gypsum and sandstone accelerates further decay. Additionally, the lack of scientific rigor in mixing the gypsum with sand means the repair is unstable, allowing moisture, wind, and other degrading elements to penetrate deeper into the temple's walls, exacerbating the existing damage.

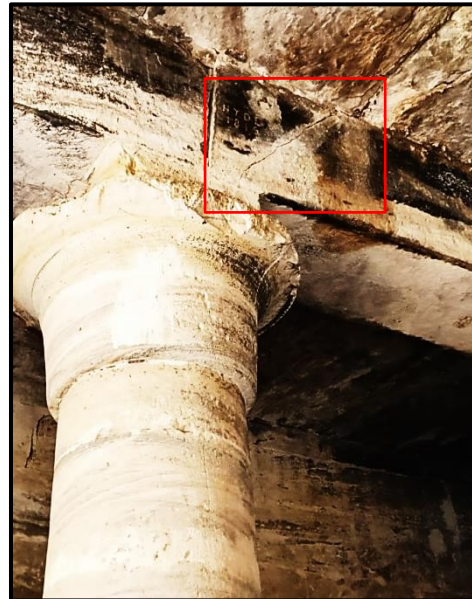
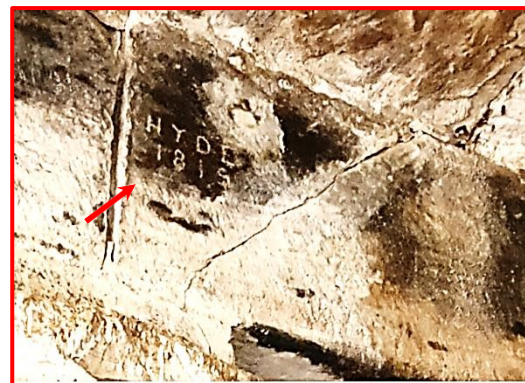
Figure 20. Inscription of "Hyde 1819" on the Ceiling of the Doush Temple

The temple has also suffered from human intervention in the form of modern graffiti. One of the most notable inscriptions on the temple's ceiling is the name "Hyde 1819," believed to be left by the British archaeologist John Hyde, a significant figure from the early 19th century. His inscription is particularly interesting because it was carved in a neat, organized manner, suggesting it was not a hurried act of vandalism but a deliberate marking (Fig. 20). This has raised questions about how Hyde managed to reach such a high spot on the ceiling of the hypostyle hall. One plausible explanation is the presence of accumulated sand, which may have filled the

lower parts of the temple, making the ceiling more accessible. The region around Doush is known for its sand dunes and shifting sands, which can dramatically alter the landscape over time. If sand had indeed filled a large portion of the temple during Hyde's visit, it would have allowed him to carve the inscription with ease, as the upper portions of the temple would have been within reach.
