Weathering and Its Geomorphologic Impact on Heritage Buildings at Mansoura City, Nile Celta, Egypt: A Geomorpho-archaeologic Study

Sherine Sabry Elsebaei^{1,*}, Sarah Ali Fathy Hamaiel²

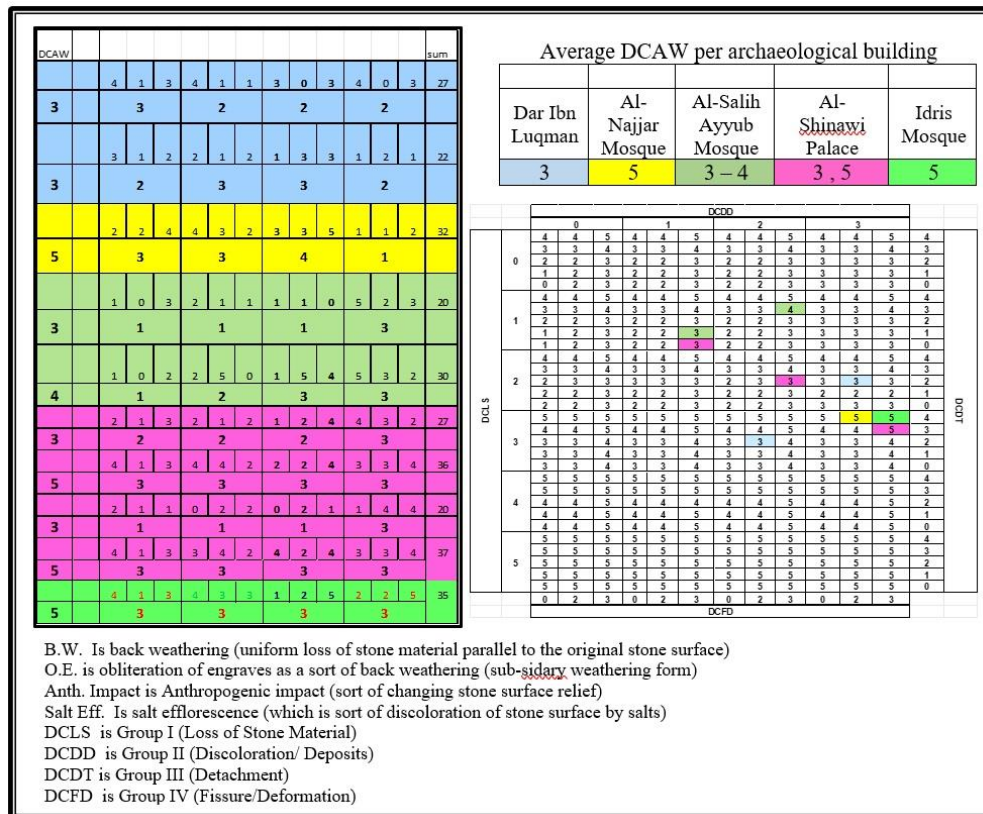
Figure 19: A graphical model that determines the degree of damage to the rock surface according to the classification (Fitzner et al., 2002)

all the weathering features had been considered to semi-quantify the damage category based on this non-destructive technique of [Fitzner and Heinrichs \(2002\)](#). The weathering features and their dimensions had been listed in Table.4. Then, they are grouped into the four groups to find out the damage category of each heritage considering all weathering forms. The grouping of weathering features and recording the intensity of each parameter of each feature enabled defining the damage category regarding each feature. Accordingly, using the DCAW of [Fitzner³ and Heinrichs \(2002\)](#) enabled defining the overall damage category of each heritage building
