# Weathering and Its Geomorphologic Impact on Heritage Buildings at Mansoura City, Nile Celta, Egypt: A Geomorpho-archaeologic Study

## ABSTRACT

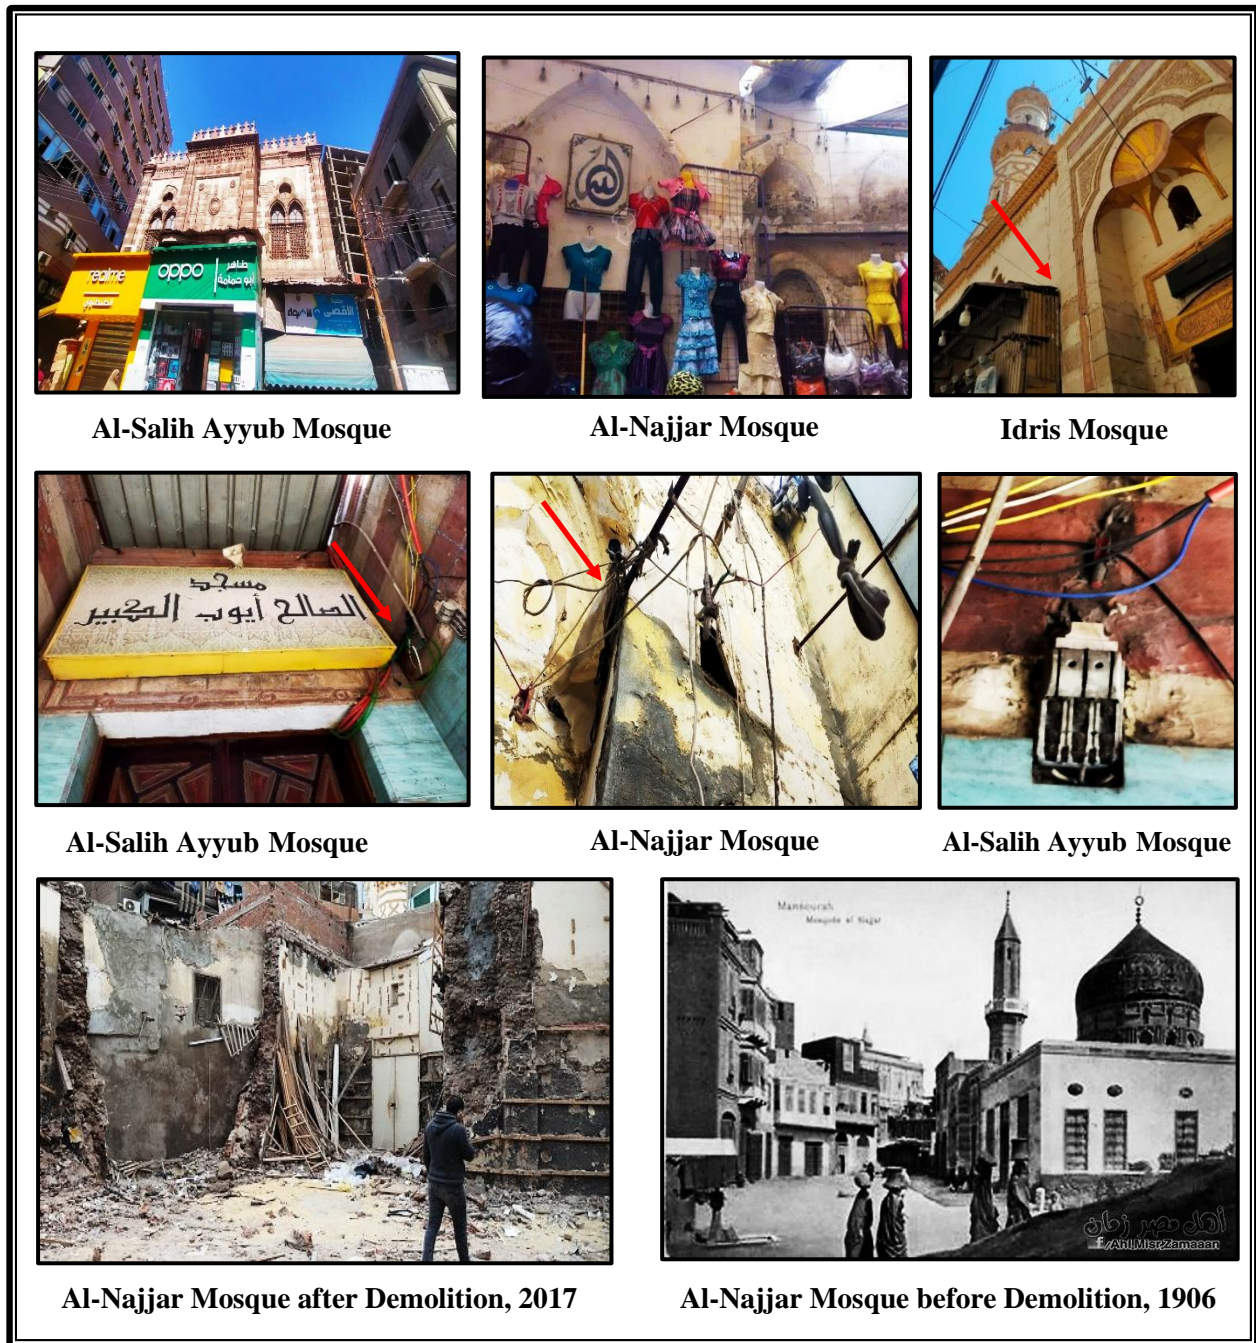
**Figure 3.** Examples of Human Encroachments on Heritage Buildings in Mansoura City

Recently, these heritage buildings suffered deterioration in their external form because of many factors that had interacted together resulting in weathering forms on their building materials including the anthropogenic

impact. This is considered one of the most important problems that negatively affect heritage buildings due to the high population density around these buildings, and the resulting acts of demolition, vandalism, and deterioration (Fig. 3).

Human interference with heritage buildings includes incorrect restoration operations, and the demolition of some mosques after decisions to remove them were issued by some concerned authorities due to their exposure to collapse. They were consequently replaced by other buildings, as is the case with the Al-Najjar Mosque, of which only one archaeological wall remains. In addition, there is the urban

encroachment on heritage buildings proximity which includes markets encroachment and shops underneath the mosques being rented out to some merchants, as is the case in the Great Mosque of Al-Salih Ayyub that was had shops underneath it rented for the purpose of profit. Moreover, there are many violations and attacks by street vendors which concealed the features of the mosques and their heritage value by exploiting the

surroundings and walls of the mosques to display and hang their goods, place commercial signs on them, and randomly exposed electricity wires. Added to this is the deterioration of the infrastructure networks such as water and sewage networks, near surface domestic water that seepage from domestic pipes of buildings around these heritage structures, There is also the accumulation of waste and dust on buildings, which ultimately leads to distorting their architectural form and historical landmarks and thus threatening the cultural and heritage image of the building, as well as renting them from government agencies to perform a function other than the one for which they were created, such as exploiting Al-Shinawi Palace to be a building for the Antiquities Authority in Mansoura City.

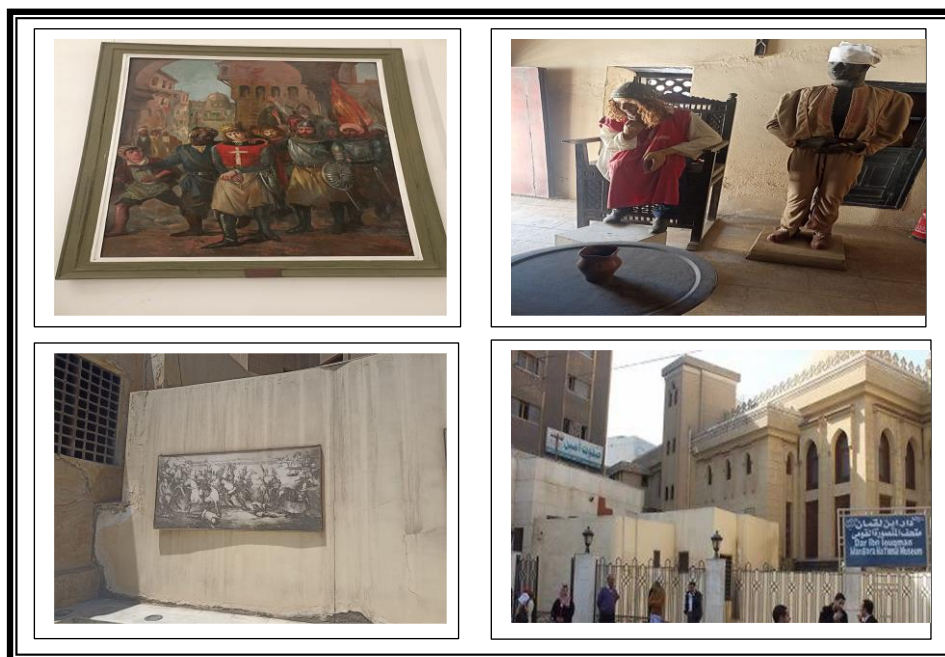
Source: Field Study (2024).  
**Figure 5.** Description of Dar Ibn Luqman

The house was transformed into the Mansoura National Museum in 1997 due to its historical importance, as king Louis the nineteenth, the leader of the Seventh Crusade, was imprisoned there after his capture in the Battle of Fariskur in Muharram 648 Hijri (Fig. 5), and King Louis was taken away in shackles (Al-Nuwairi, 1992, 29/ p.356). Transforming the house into a national museum was achieved in commemoration of the victories of Egypt and its army that took place in the Dakahlia

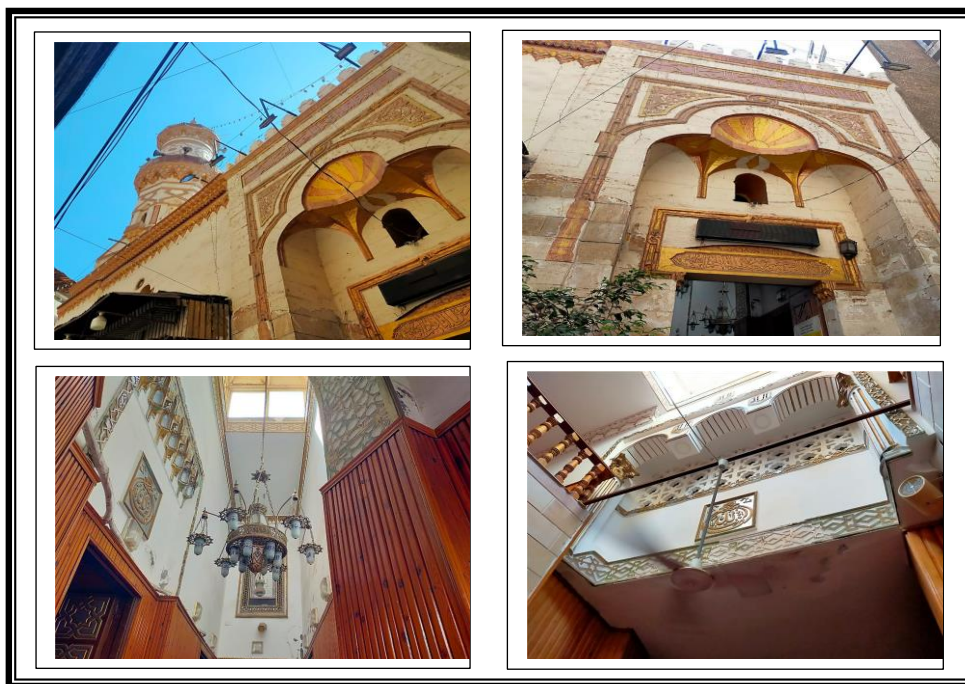
**Figure 6.** Description of Idris Mosque

It is one of the ancient mosques in the city of Mansoura, where its construction dates back to the year 577 AH. The mosque is distinguished by being built in the style of Ayyubid mosques and schools, as it begins with the entrance, which leads to a path surrounded by a number of rooms on both sides, then an iwan for prayer, and stone carved with large dimensions was relied upon to decorate it. The facade of the mosque, the ceilings are supported by vaults, the appearance of muqarnas on the facades of the mosque, the exchange of colors of stones in the facades (Fikri, 2008, pp. 77-80) It is also distinguished by its minaret, which resembles the minaret of the Great Mosque of Salih Ayyub, known as the Mahmoudiya Mosque, as one can ascend to it from a door near the main entrance of the mosque and its staircase is made of carved stone, and muqarnas adorn its balconies (Fig. 6).

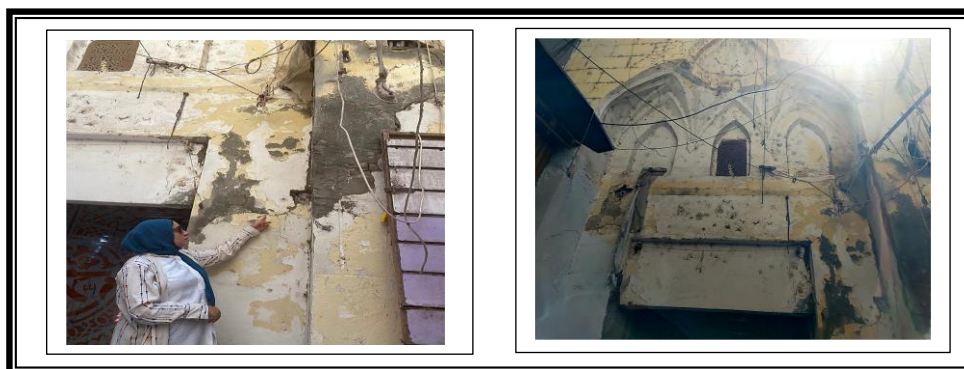
**Figure 7.** Description of Al-Najjar Mosque

The construction of Al-Najjar Mosque dates back to the year 566 AH / 1170 AD. It was built by the devotee Muhammad Al-Najjar, for whom the mosque was named. It is located in the Al-Khawajat Market area in Mansoura, off Port Said Street. A shrine was erected for the devotee Muhammad Al-Najjar, and he was buried in it inside the mosque. A birthday celebration was held annually, and the mosque was distinguished by its inclined minaret, which resembled the Tower of Pisa, but it is currently demolished: the entire mosque and shrine. In fact, only part of the entrance and gate remains (Supreme Council of Antiquities, unpublished excavation reports, 2024), (Fig. 7).

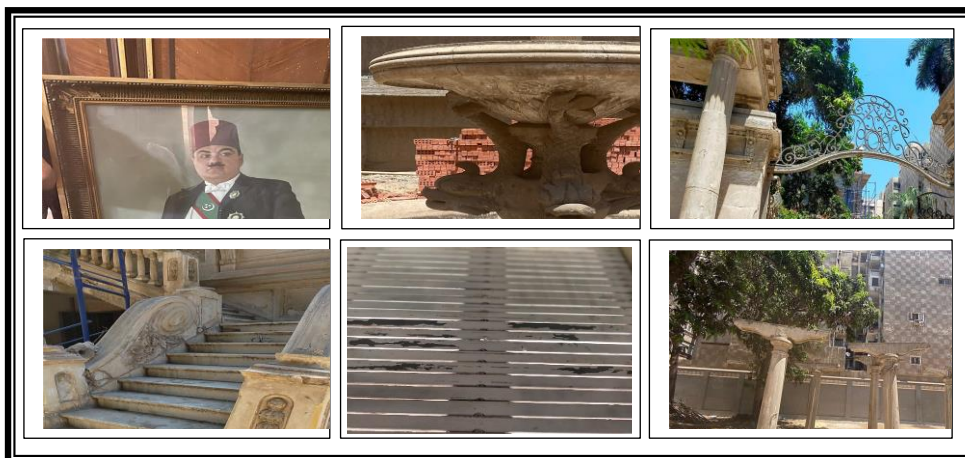
**Figure 8.** Description of Al-Shinawi Palace

The total area of the palace is about one acre, and the buildings occupy 441 square meters. The palace consists of a basement, a ground floor, and a first floor. In the middle of the palace is a garden containing tennis courts, a billiard room in the basement, rare trees, and a heritage fountain in the background of the palace. The palace's view of the Nile River was in the past, before the heirs sold a large part of it for the establishment of an investment project. The palace also contained a roofed trellis made of Doric-style columns. It was probably intended for playing and holding dance parties. It had two entrances, a main entrance and an entrance for servants. Manual aluminium shutters and mats were used in the palace windows to close the windows and balconies (Shehata, 2002, pp. 117-130), (Fig. 8).

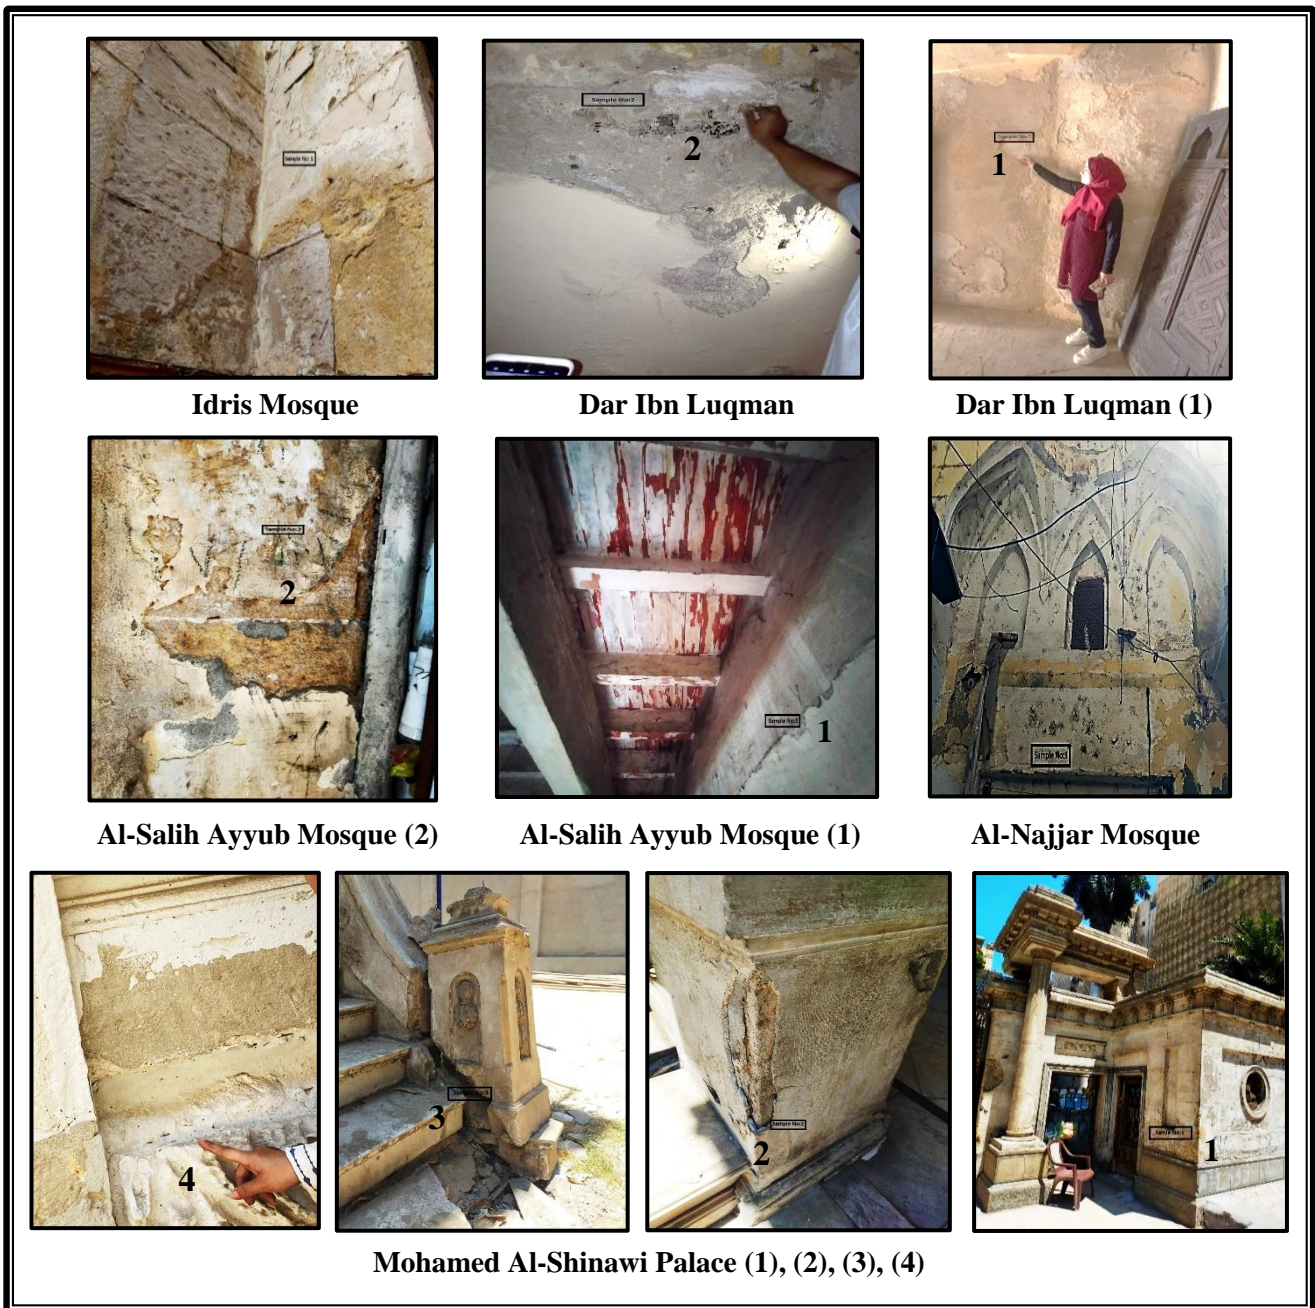
**Figure 14.** Sampling locations of heritage buildings of Mansoura City

Ten samples were collected from the five heritage buildings under investigation in a non-destructive manner through field work (Fig. 14) and tested in the laboratory to identify the natural characteristics of the rocks, as the properties of building materials determine the type of damage and deterioration to which exposed

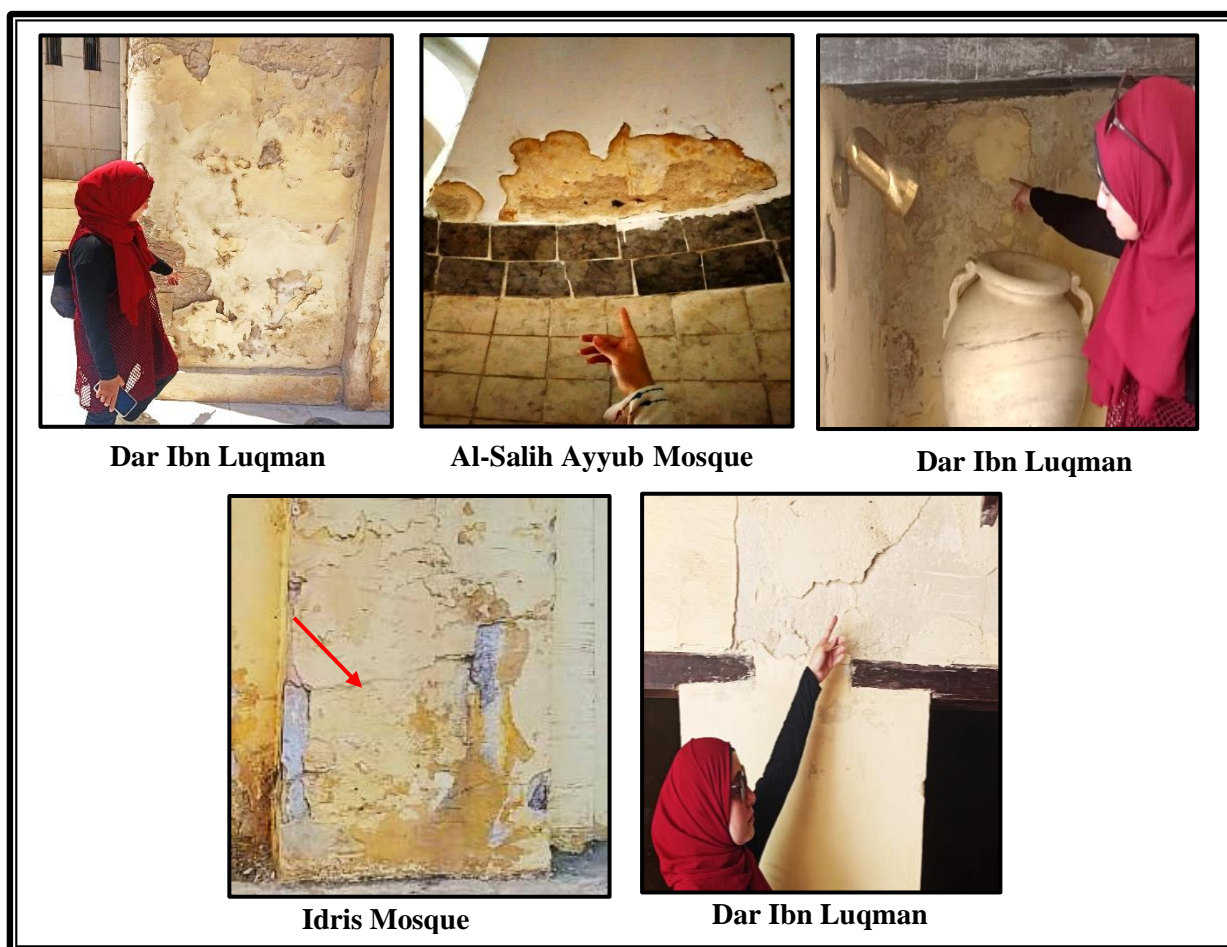
**Figure 20:** The Spread of the Phenomenon of Flaking in the Stone of heritage buildings

solution through the pores of the structure does not bring new liquid to the surface at a speed commensurate with the speed of evaporation, then a dry area expands. Gradually just below the surface, the dissolved salts are then deposited inside the stone at the border between the wet and dry area, resulting in crusts (Al-Homosani, 2007, p. 136).

It has been shown that the phenomenon of peeling is widespread in some archaeological buildings, such as Dar Ibn Luqman and the Great Mosque of Al-Salih Ayyub, with thicknesses ranging between 1 and 8 mm due to their exposure to humidity and salt weathering, and then the accumulation and crystallization of salts inside the pores of stone, especially limestone, such as sodium and magnesium sulfate salts, thus exposing them to corrosion and peeling (Fig. 20).

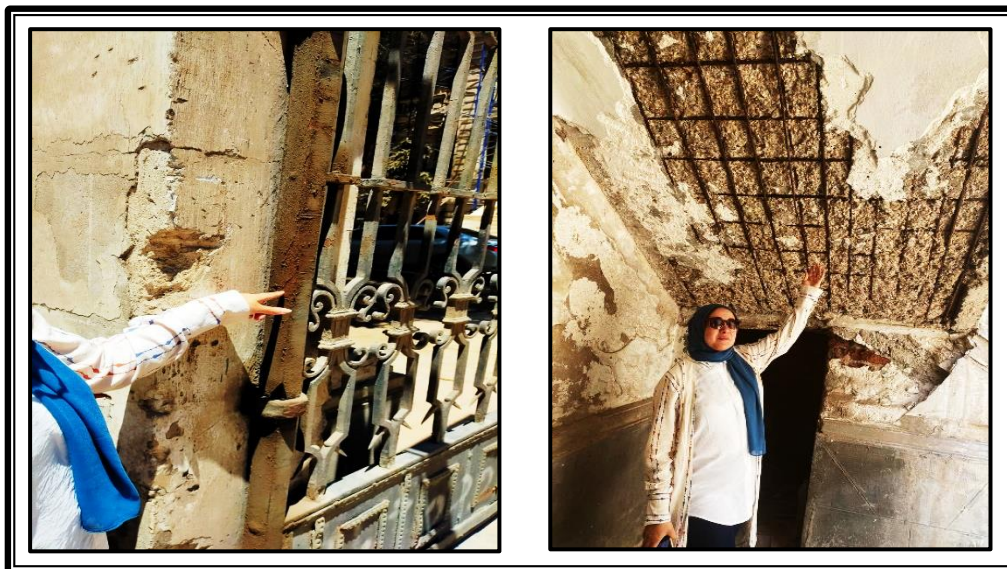
**Figure 24.** Rusting iron in the Al-Shinawi Palace building in Mansoura City

Iron rust is one of the dangers facing the city’s archaeological and heritage buildings, which exposes them to damage. It is a reddish-brown colour that appears on the surface of the iron. The colour varies according to the chemical composition of the metals on which the rust forms. This phenomenon is clearly widespread in the El-Shennawy Palace building (Fig. 24). As a result of the combination of dissolved iron ions

with water to form iron (III) hydroxide, which occurs more quickly when iron is oxidized with oxygen atoms or water, especially salt water. This is because water combines with carbon dioxide present in the air and produces weak carbonic acid and the iron begins to decompose. Therefore, the problem of iron rust must be overcome by adding some other rust-resistant metals, such as nickel and chromium, to form rust-resistant stainless steel.
