Weathering and Its Geomorphologic Impact on Heritage Buildings at Mansoura City, Nile Celta, Egypt: A Geomorpho-archaeologic Study

Sherine Sabry Elsebaei^{1,*}, Sarah Ali Fathy Hamaiel²

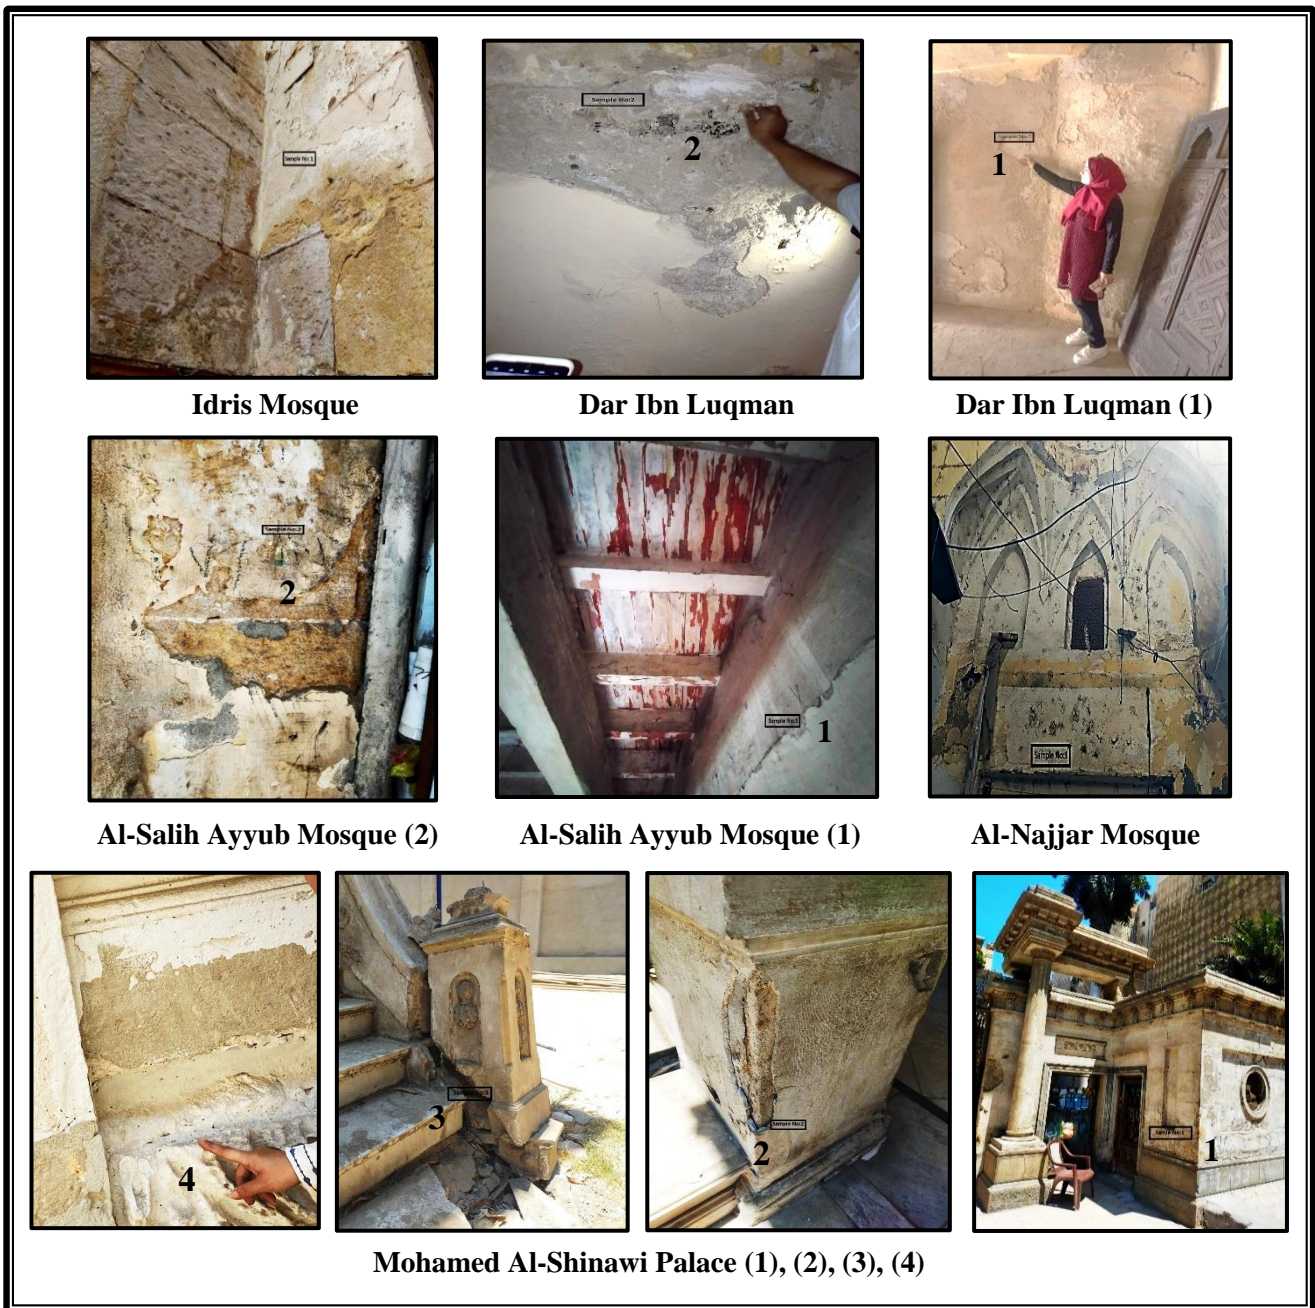
Figure 14. Sampling locations of heritage buildings of Mansoura City

Ten samples were collected from the five heritage buildings under investigation in a non-destructive manner through field work (Fig. 14) and tested in the laboratory to identify the natural characteristics of the rocks, as the properties of building materials determine the type of damage and deterioration to which exposed

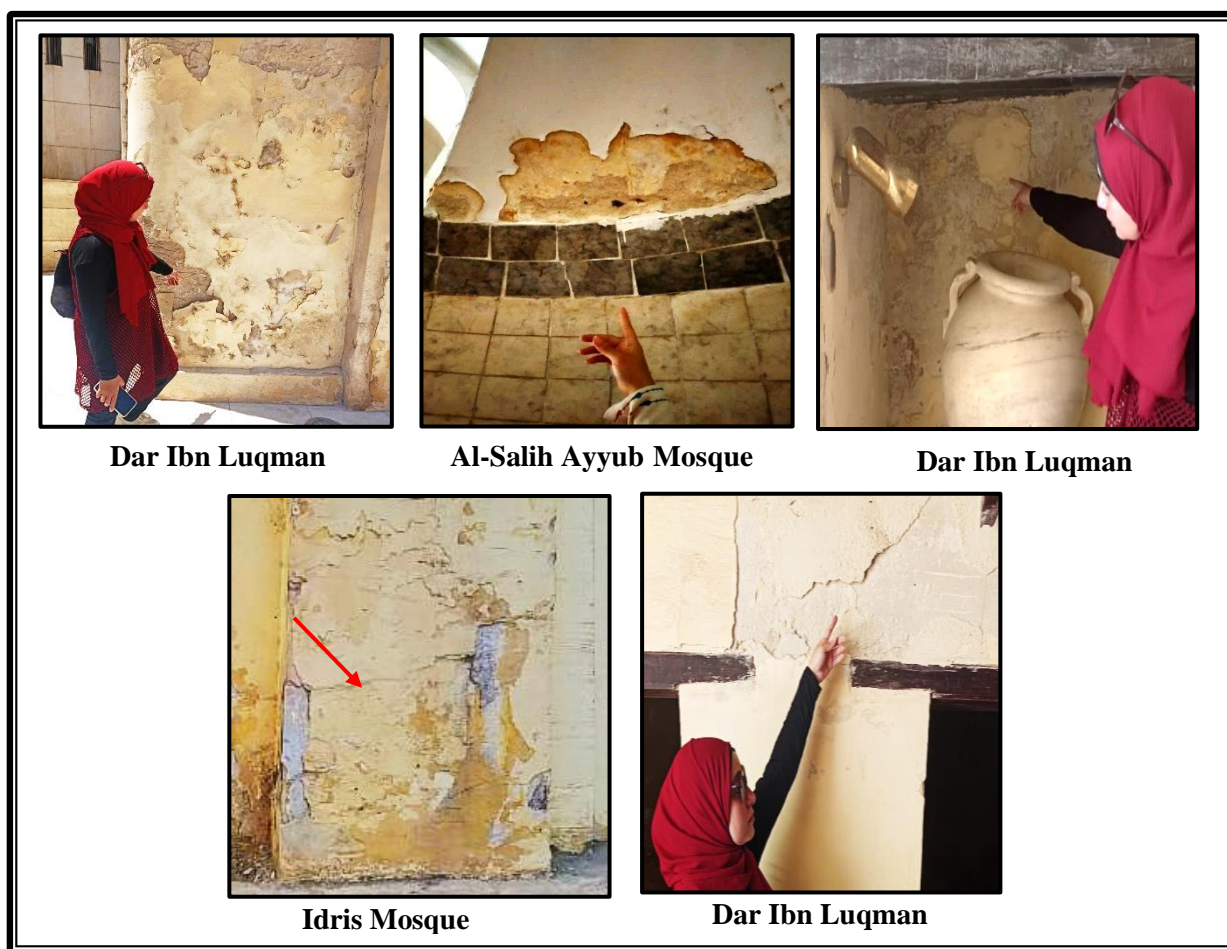
It has been shown that the phenomenon of peeling is widespread in some archaeological buildings, such as Dar Ibn Luqman and the Great Mosque of Al-Salih Ayyub, with thicknesses ranging between 1 and 8 mm due to their exposure to humidity and salt weathering, and then the accumulation and crystallization of salts inside the pores of stone, especially limestone, such as sodium and magnesium sulfate salts, thus exposing them to corrosion and peeling (Fig. 20).

Figure 20: The Spread of the Phenomenon of Flaking in the Stone of heritage buildings

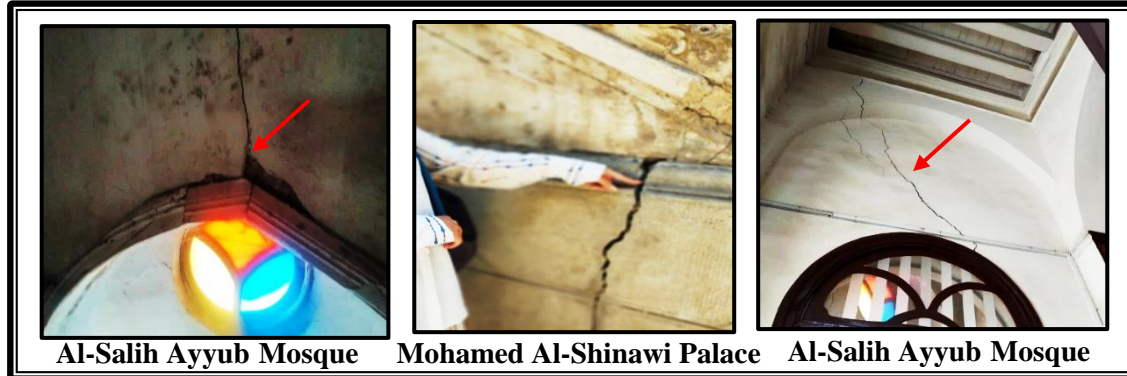
Figure 23. Cracks in some heritage buildings of Mansoura City

of the facility. To study the conditions of the soil beneath the building, measure the crack, and determine its width, while placing a mark at both ends of the crack with the necessity of making a gypsum “bug” approximately 2 mm thick to ensure faster and more accurate results, along

with monitoring these cracks daily to notice the crack activity. If the crack activity is proven with knowledge of its direction, this means that there is a defect in the building (Supreme Council of Antiquities, unpublished reports, 2024), in order to begin its restoration and process it properly.
